Inspection Report

Property Address:
1234 Main Lane
Ellenton FL 34222

Best Home Inspection and Construction Company, LLC

Date: 9/14/2018	Time:	Report ID: 2018-9876
Property: 1234 Main Lane Ellenton Fl 34222	Customer: John Doe	Real Estate Professional: Judi Taulbee Fine

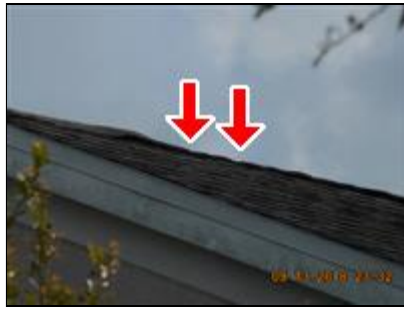
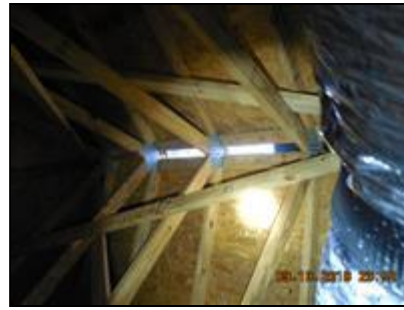
1.0 (Picture 5)

(Picture 5) (Picture 6) Shingles missing from ridge vent. Mesh in place. Daylight visible in attic.

We recommend a licensed roofing contractor to further inspect the entire roof covering, flashings, and ventilation penetrations. Some minor repairs are required.

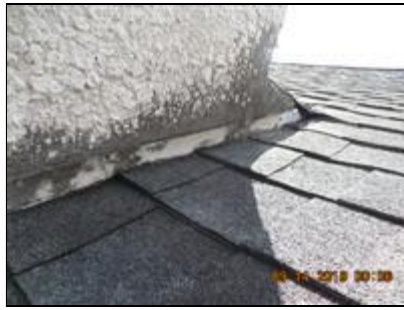
1.0 (Picture 13)

(Picture 12) Stains on soffit consistent with leakage.
(Picture 13) Possible entry point along flashing at tower corner.
(Picture 14) (Picture 15) Or, at kickout flashing at drip edge.
(Picture 16) No staining or heightened levels of moisture were observed.

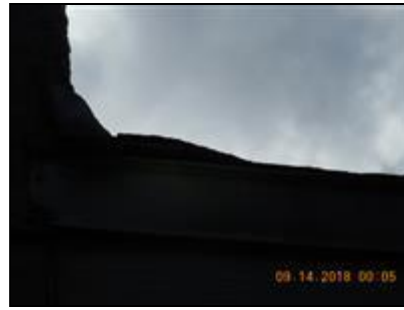
1.0 (Picture 14)

(Picture 14) (Picture 15) Or, at kickout flashing at drip edge.

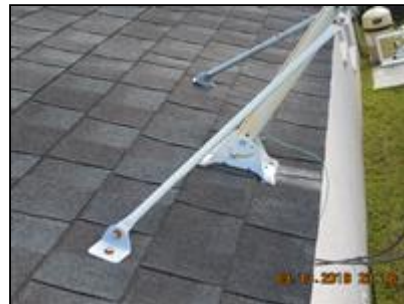
1.1 (Picture 12)

(Picture 12) A satellite dish is mounted on the roof covering. This is a potential leak spot and should be monitored.

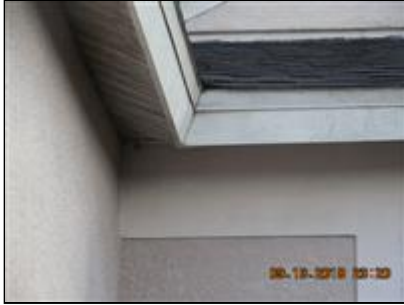
1.2 (Picture 1)

(Picture 1) (Picture 2) Top level dumps onto lower level. Over time, this will wear down the shingles on the lower level. Also, it will cause fungal growth on the lower level.

1.2 We recommend installing a roof drainage system around the entire perimeter of the house. Gutter and downspouts are a critical component in protecting your foundation and landscaping around the house from erosion. We recommend a licensed contractor to perform this task.

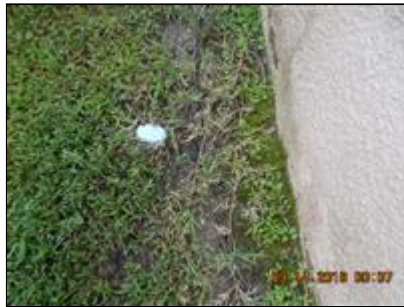
1.2 (Picture 5)

(Pictures 3 - 5) There is very poor drainage on the sides of the house. Installing gutters at the top level will help alleviate this situation.

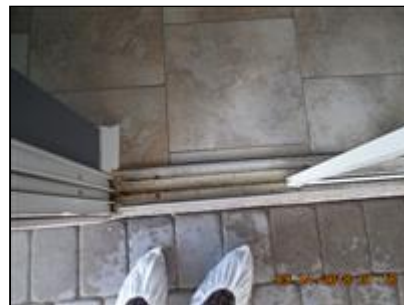
2.4 (Picture 3)

2.4 The track system(s) for the sliding glass door(s) need(s) to be cleaned of dirt and debris. Over time, these particles will wear down the rollers on the doors. A competent person should vacuum and/or wipe the track clean.

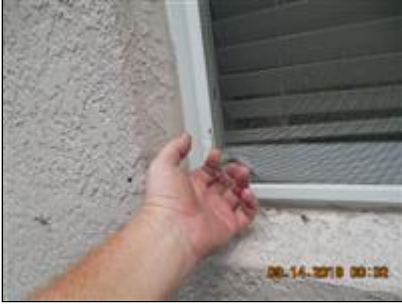
2.5 (Picture 1)

2.5 There is a ripped or damaged window screen on the right side.

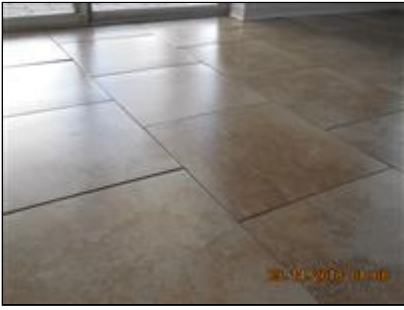
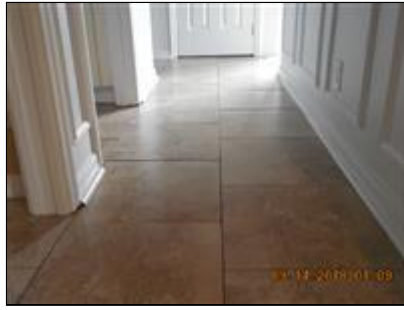
3.4 It appears that some of the slab might be not level.

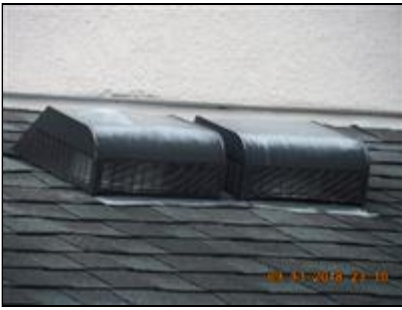
4.4 (Picture 1)

4.4 As reported in Section 1.0, there is a damaged ridge vent on the top story which is allowing water to enter the attic.

(Picture 1) The off-ridge ventilation units are flashed properly and are functioning properly as well.

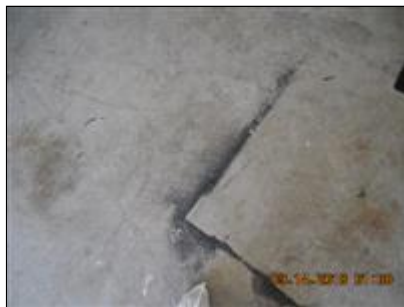
5.3 (Picture 2)

5.3 The garage floor needs to be cleaned. We recommend a licensed handyman or competent person to acid wash and clean the floor surface and then re-paint or seal as necessary to prevent further staining.

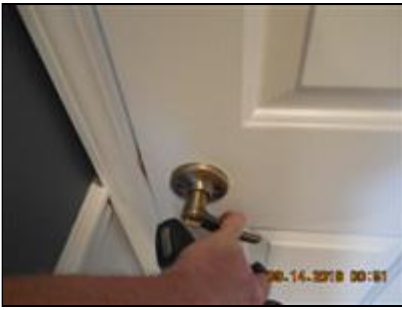
5.4 (Picture 1)

5.4 The occupant door needs adjustment to close more easily.

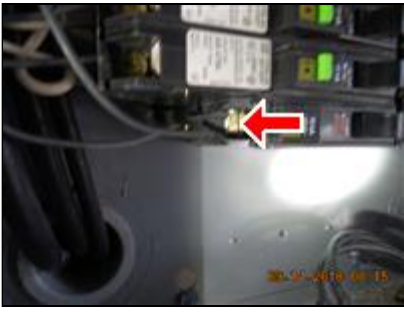
7.3 (Picture 1)

7.3 We recommend a licensed electrician inspect what appears to be one double lug in the panel box. There appears to be room for (slim-line) breakers and we recommend that the electrician address this.

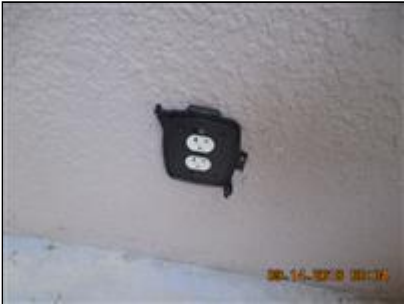
7.4 (Picture 1)

7.4 (Pictures 1 - 3) The exterior receptacles are missing bubble covers.

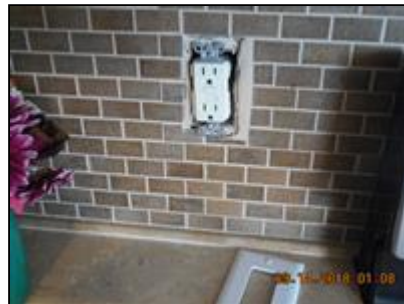
7.4 (Picture 9)

(Picture 9) One receptacle cover in the kitchen is loose.

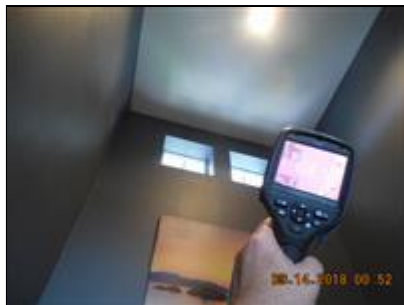
9.2 (Picture 8)

9.2 As discussed in the roofing section, there is a minor amount of heightened moisture in the ceiling of the top level hallway near the landing.

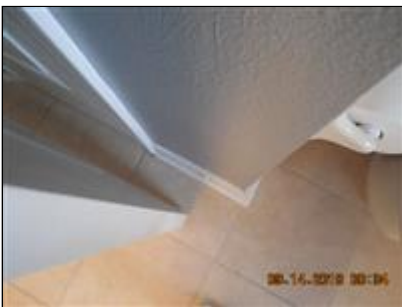
9.4 (Picture 1)

9.4 Some of the door bumpers are missing or damaged. We recommend a competent person or licensed handyman install these where needed to prevent damage to the walls or baseboards.

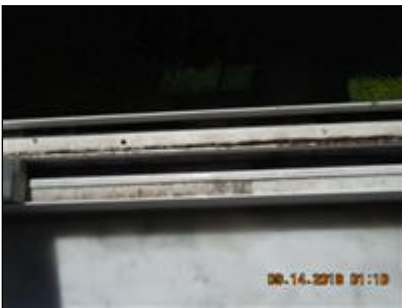
9.5 (Picture 1)

9.5 (Pictures 1 - 3) We suggest cleaning out all window frames and track systems. Insect nests, dirt and debris will cause window components to corrode and not operate to their full potential.

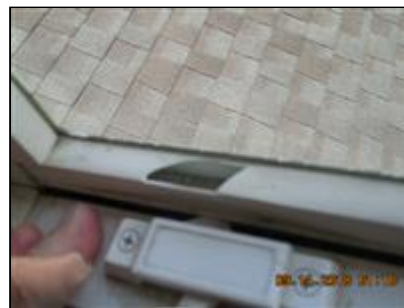
9.5 (Picture 6)

(Picture 5) (Picture 6) The glazing bead is damaged at some locations. We recommend a licensed window and door company to repair as necessary.

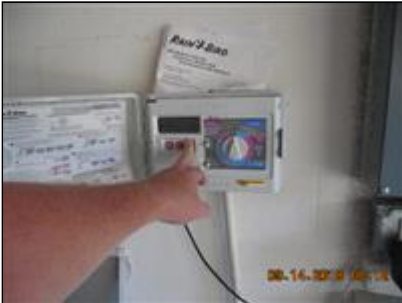
11.0 (Picture 1)

11.0 We ran the system in manual mode. None of the zones operated when tested. A licensed irrigation company should further inspect the entire system and repair as necessary.
