Inspection Report

Property Address:
1234 Main Lane
Ellenton FL 34222

Best Home Inspection and Construction Company, LLC

Date: 9/14/2018	Time:	Report ID: 2018-9876
Property: 1234 Main Lane Ellenton Fl 34222	Customer: John Doe	Real Estate Professional: Judi Taulbee Fine

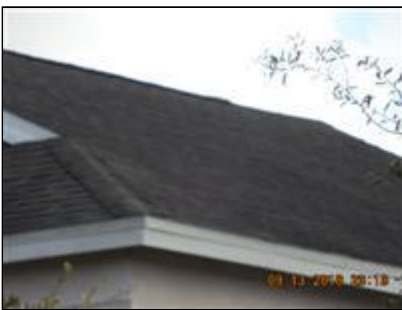
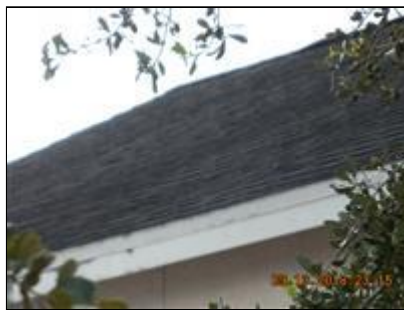
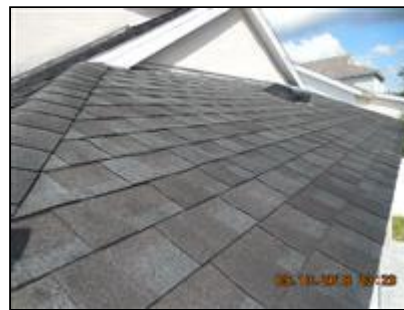
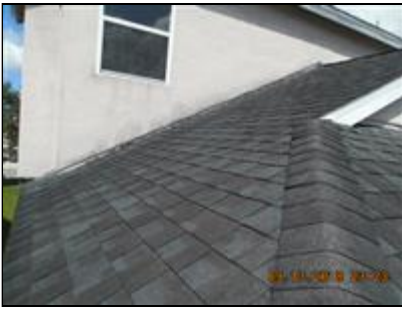
1.0 (Pictures 1 - 4) The age of this roof is 12 years; we estimate that there are 6 to 10 years of remaining life.

We recommend a licensed roofing contractor to further inspect the entire roof covering, flashings, and ventilation penetrations. Some minor repairs are required.

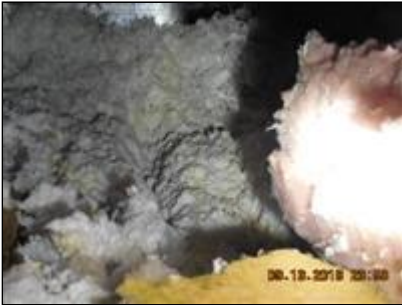
1.0 (Picture 7)

(Picture 7) Insulation wet and compacted. This condition has existed for some time.

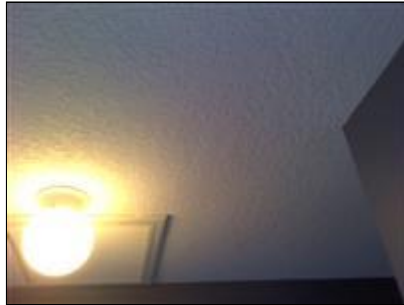
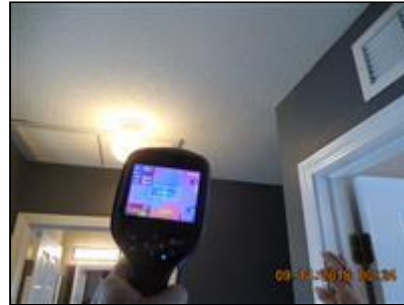
(Pictures 8 - 10) No staining on ceiling; but, some heightened moisture in drywall.

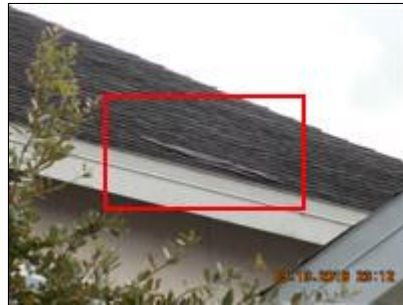
1.0 (Picture 11)

(Picture 11) Disturbed area of shingles.

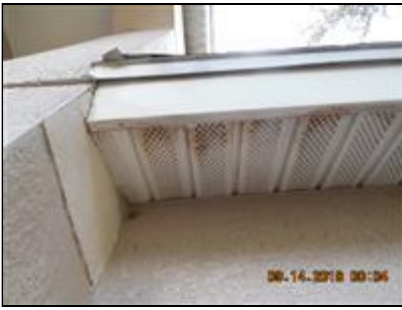
1.0 (Picture 12)

(Picture 12) Stains on soffit consistent with leakage.

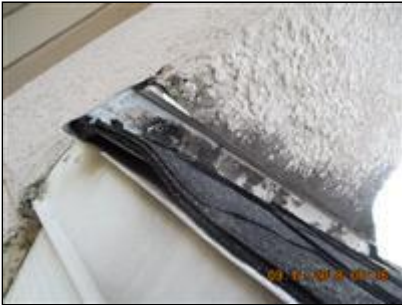
1.0 (Picture 15)

(Picture 14) (Picture 15) Or, at kickout flashing at drip edge.

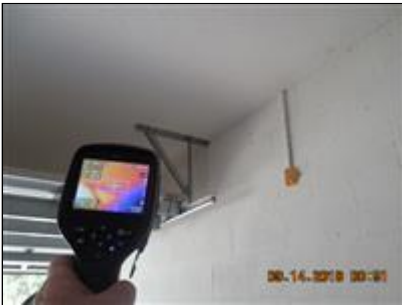
1.0 (Picture 16)

(Picture 16) No staining or heightened levels of moisture were observed.

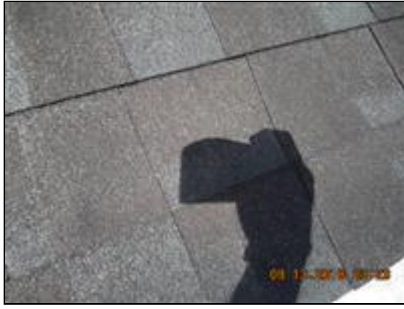
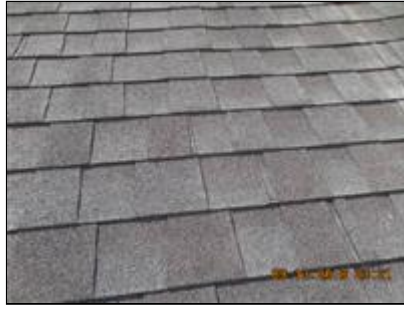
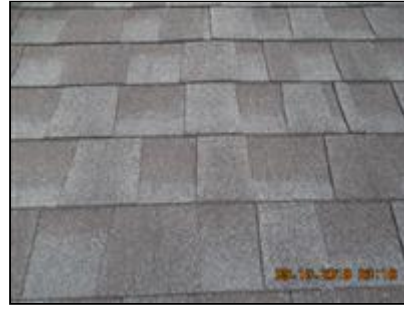
1.1 (Pictures 1 - 3) Granule wear = Normal, Minor to moderate.

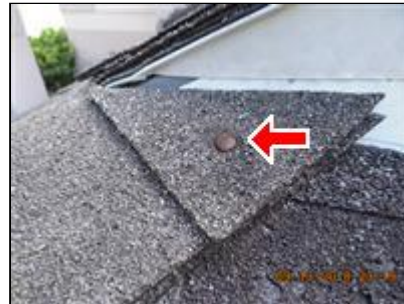
1.1 (Picture 9)

(Picture 9) Exposed Nails = Yes, on ridge lines only.

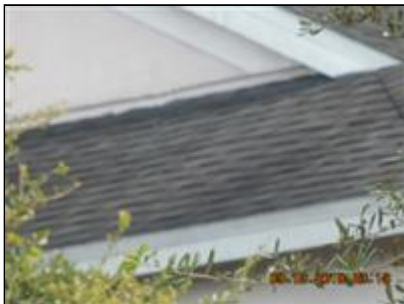
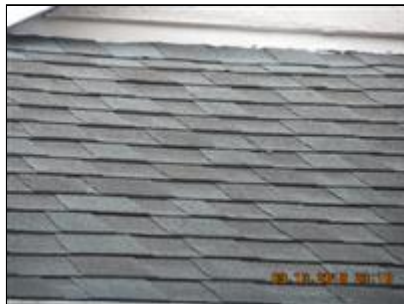
(Picture 10) (Picture 11) Fungus Buildup = Minor.

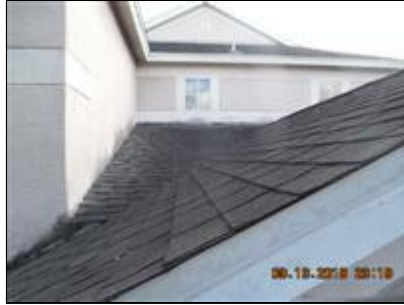
1.2 (Picture 2)

(Picture 1) (Picture 2) Top level dumps onto lower level. Over time, this will wear down the shingles on the lower level. Also, it will cause fungal growth on the lower level.

1.2 We recommend installing a roof drainage system around the entire perimeter of the house. Gutter and downspouts are a critical component in protecting your foundation and landscaping around the house from erosion. We recommend a licensed contractor to perform this task.

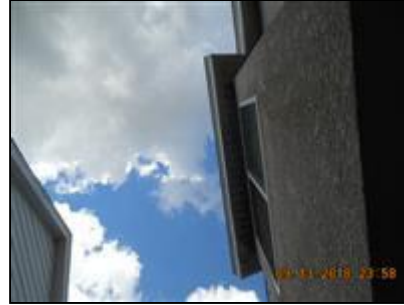
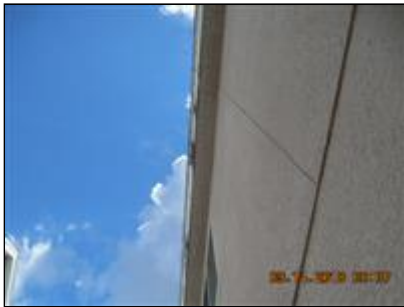
(Pictures 3 - 5) There is very poor drainage on the sides of the house. Installing gutters at the top level will help alleviate this situation.

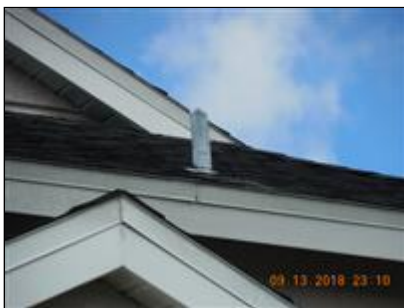
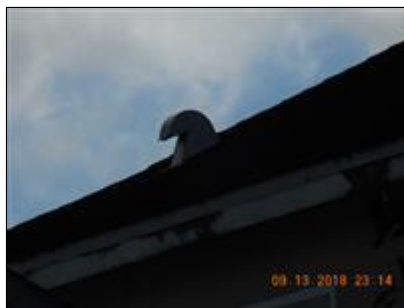
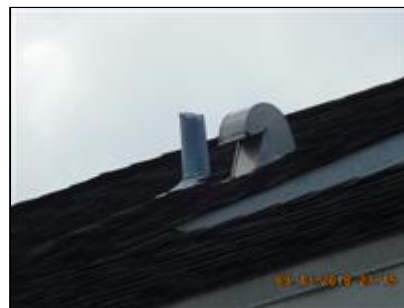
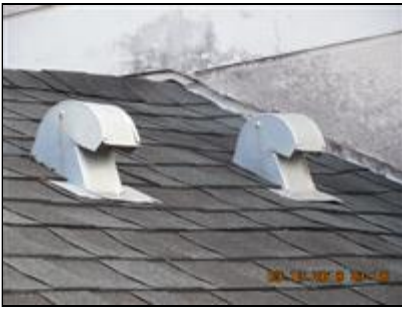
1.4 All roof penetrations appear to be flashed properly and are functioning as intended.

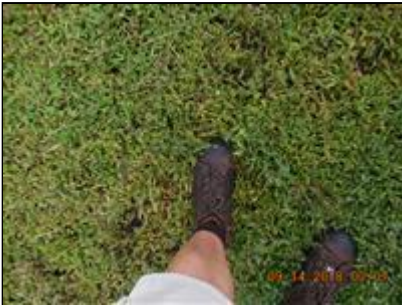
2.7 (Picture 1) As discussed in Section 1.4, there is poor drainage on the sides of the house.

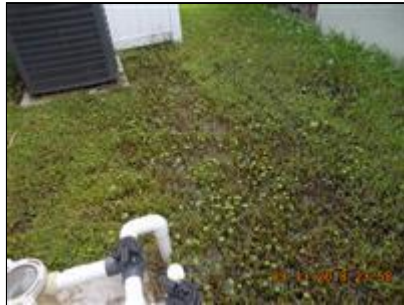
2.7 (Picture 2)

(Picture 2) This is particularly true on the right side. It appears that the terrain is not properly sloped. There is standing water adjacent to the HVAC compressor.

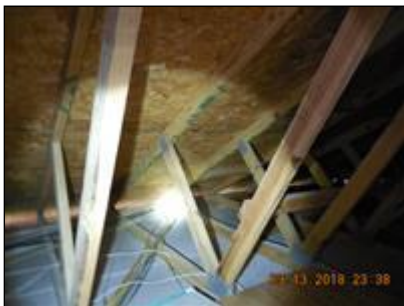
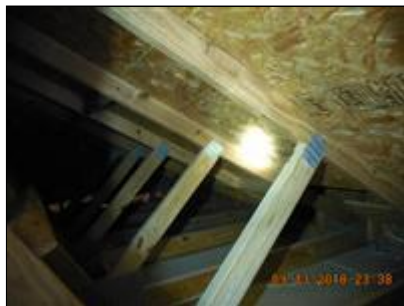
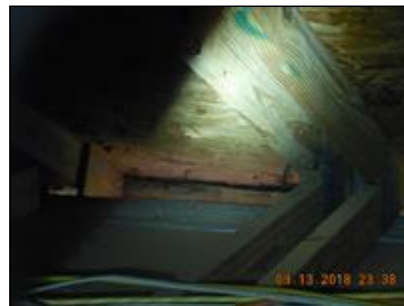
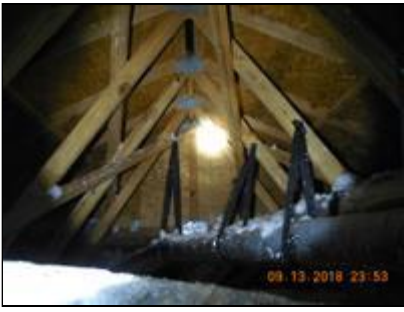
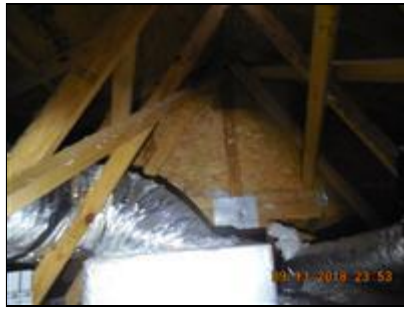
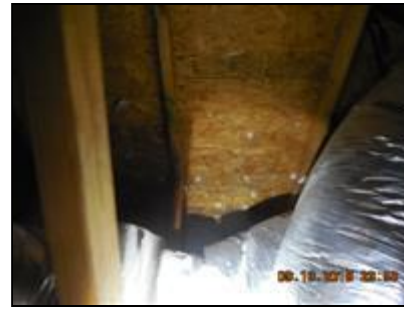
3.2 FYI - The roof structure and attic were found to be in solid condition and functioning as intended.

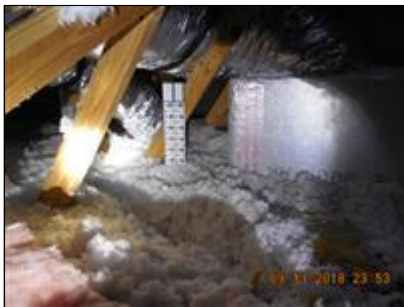
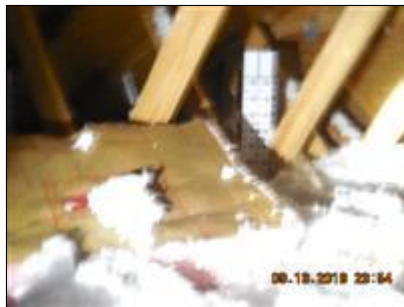
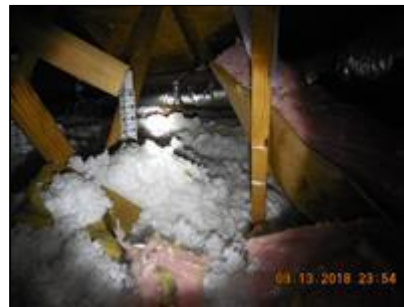
4.1 The blown insulation in the attic is estimated at an R value of 30.

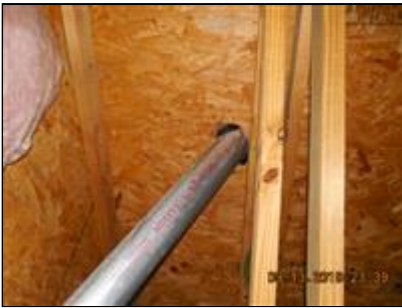
4.5 (Picture 1)

4.5 There were no apparent issues at the dryer vent penetration or vent stack. Vertical dryer vent stacks that penetrate the roof deck should be serviced on an annual basis.

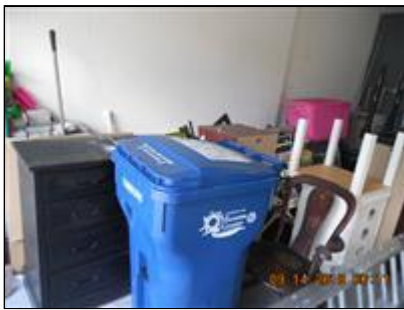
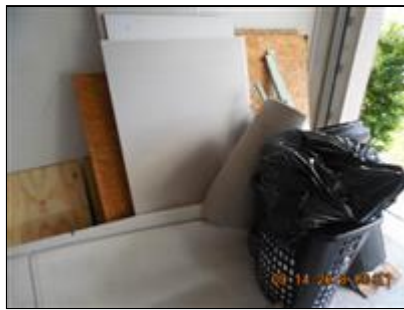
5.0 We were not able to inspect the entire garage area due to excessive amounts of personal items inhibiting observation of many floor and wall areas. Further inspection may be necessary upon removal of these items. However, there were no indications that any issues exist which warrant mentioning in this report.

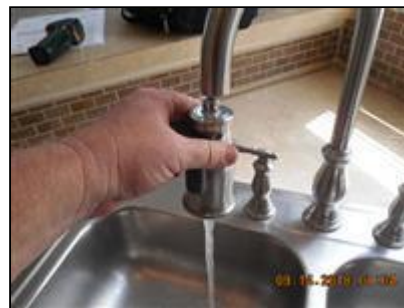
6.3 (Picture 6)

(Picture 6) Sprayer does not retract into the faucet neck properly.

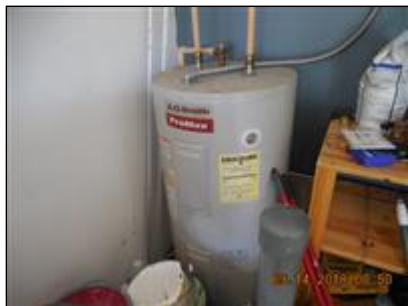
6.4 (Picture 1)

6.4 FYI - The water heater is located in the garage and is 12 years old.

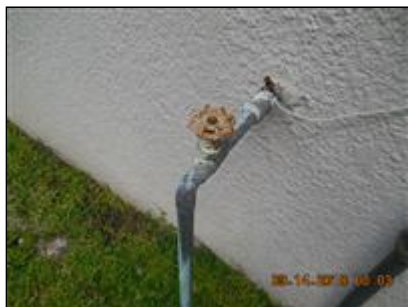
6.5 (Picture 1)

6.5 The main shut off is the knob located on the right side of the house. This is for your information.

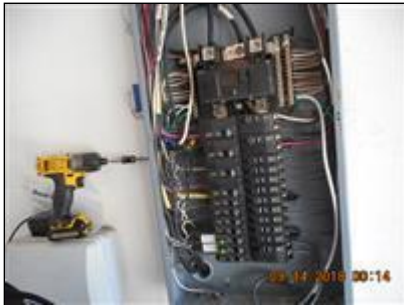
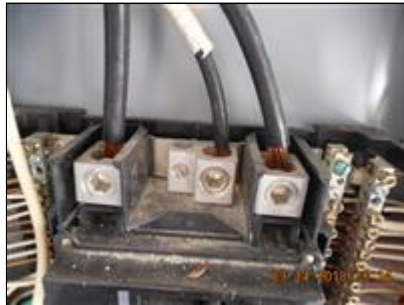
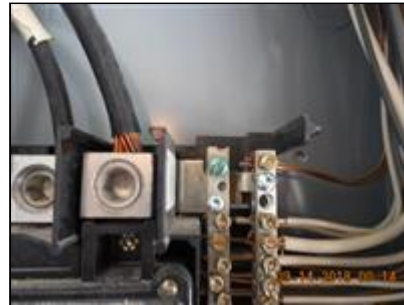
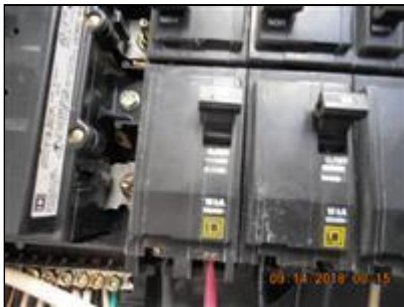
7.2 FYI - There were no major issues observed at the service panel box.

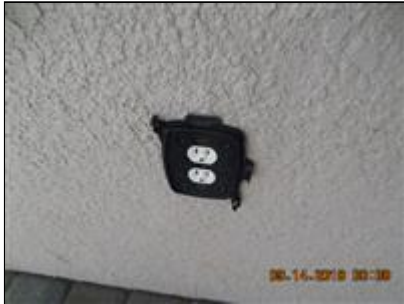
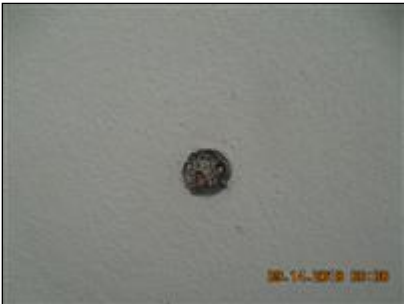
7.4 (Pictures 1 - 3) The exterior receptacles are missing bubble covers.

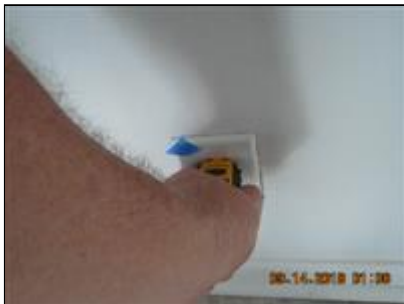
7.4 (Picture 8)

(Picture 8) We found one loose receptacle.

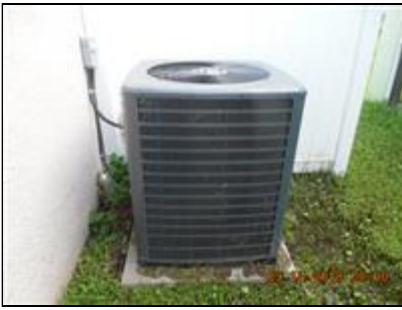
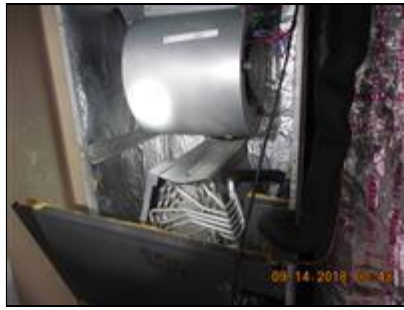
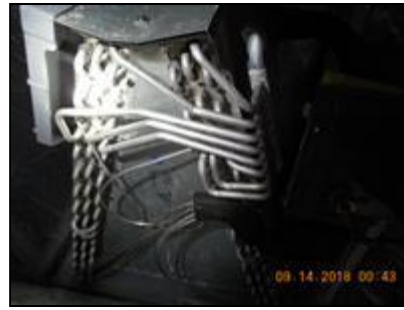
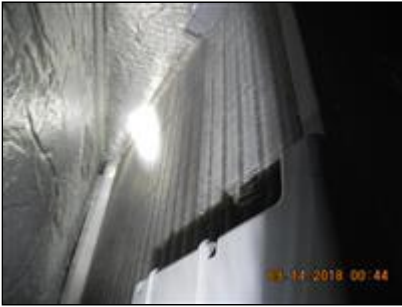
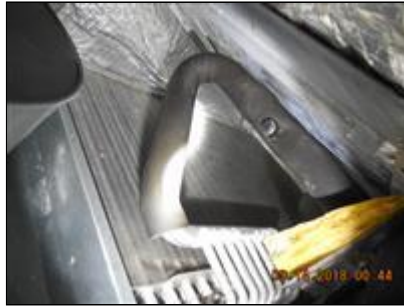
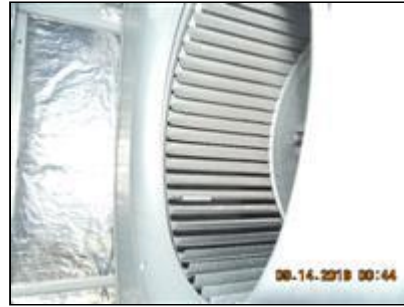
8.1 FYI - The evaporator coils and aluminum fins should be serviced by a licensed HVAC technician on a regular basis. A proper maintenance schedule of at least one (preferably two) service calls per year will help the HVAC components operate more efficiently and extend the life of the system.

The temperature differential was registered at 18 degrees which is within the normal range of 14 to 22 degrees of differential between the supply and return air temperatures.

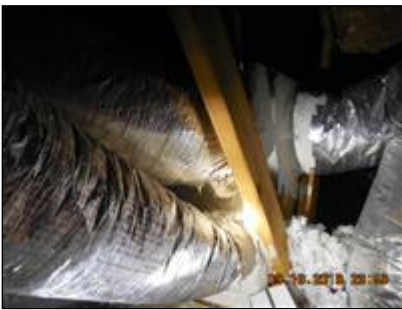
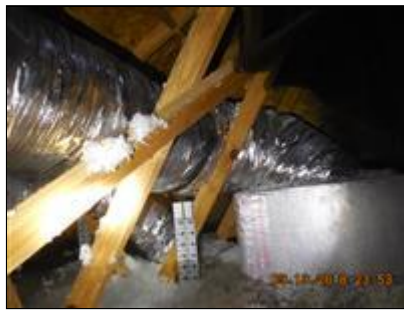
8.8 (Picture 1) (Picture 2) The ductwork appears to be intact and functioning as intended.

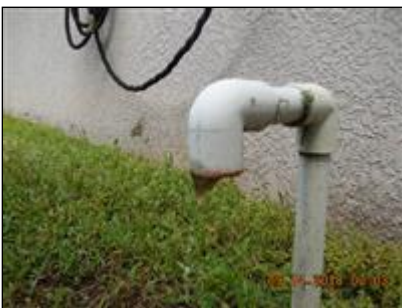
8.8 (Picture 4)

(Picture 4) We recommend that the condensate pipe be cleaned out.

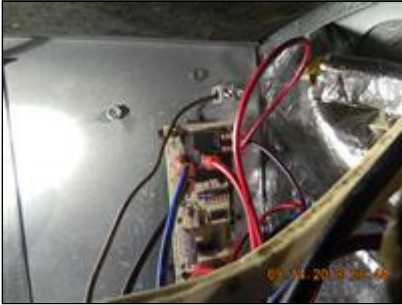
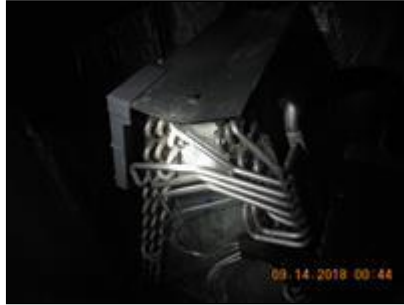
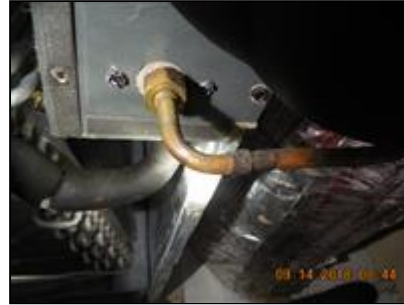
8.12 This component was inspected for the corrosive effects of sulfur-based gases emitting from defective Chinese Drywall. It is our opinion that none of the olfactory or visual characteristics associated with the premature corrosion caused by these gases were present during the inspection of this component.

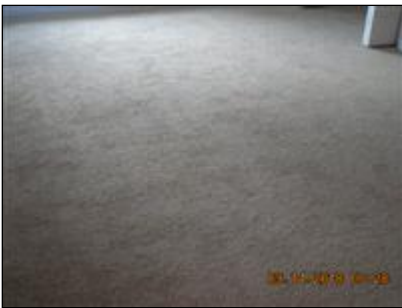
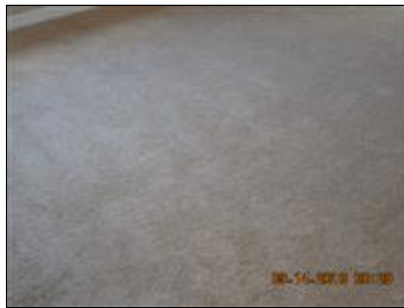
9.1 (Picture 1) (Picture 2) The carpet is new.

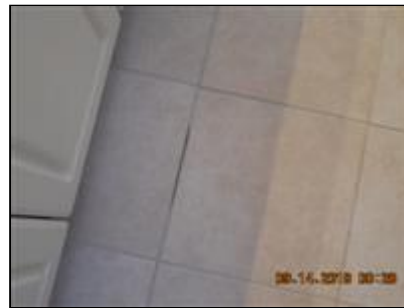
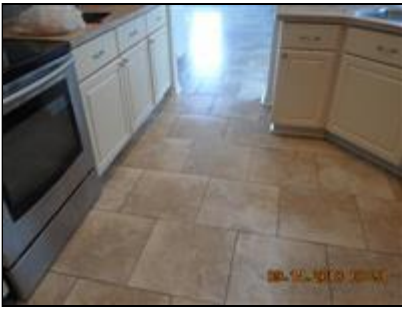
(Picture 3) (Picture 4) The grout lines for the flooring tile are stained in some areas. We recommend a licensed flooring cleaning company, licensed handyman or competent person to clean the grout as necessary.

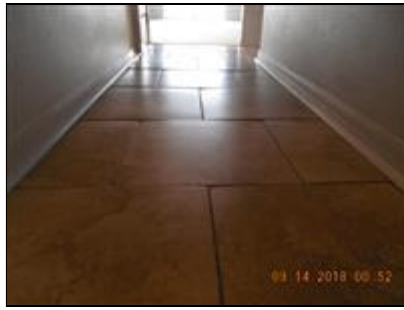
9.1 (Picture 5)

(Picture 5) Also, there are tiles which are not leveled with their adjacent tiles.

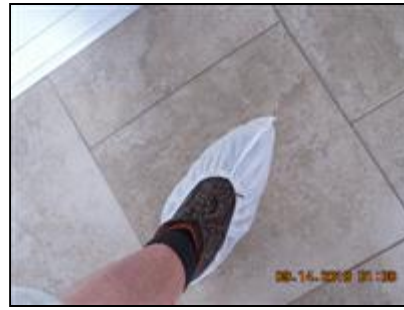
9.1 (Picture 6)

(Picture 6) The floor tile in some areas makes a hollow sound when walked on. No cracks were observed. No immediate action is required. Monitor these areas going forward.

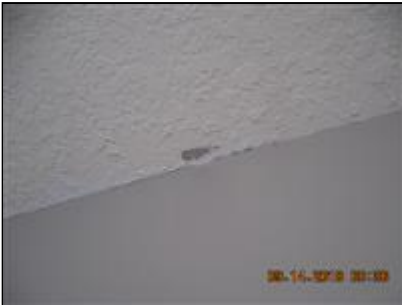
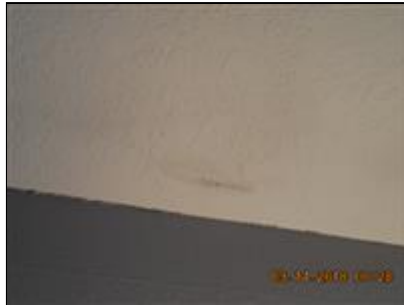
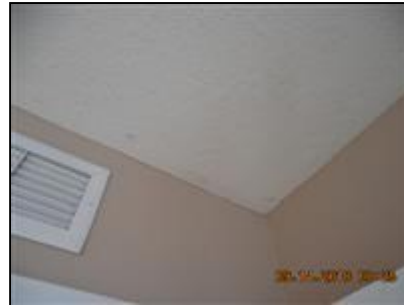
9.2 As discussed in the roofing section, there is a minor amount of heightened moisture in the ceiling of the top level hallway near the landing.

(Pictures 1 - 3) Overall, the interior of the dwelling is in solid condition. Some general (minor-cosmetic) maintenance is suggested in the form of caulking, patching and/or painting and a licensed handyman or competent person is recommended for that task.

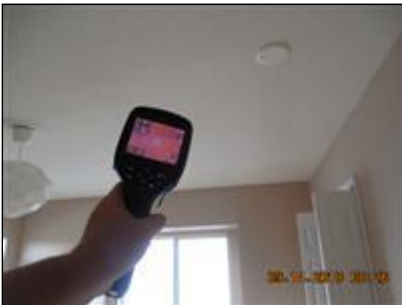
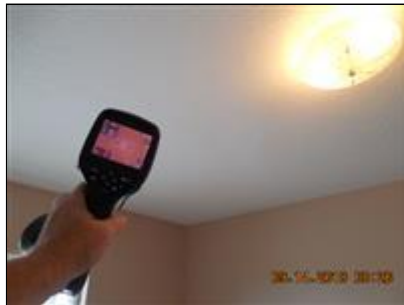
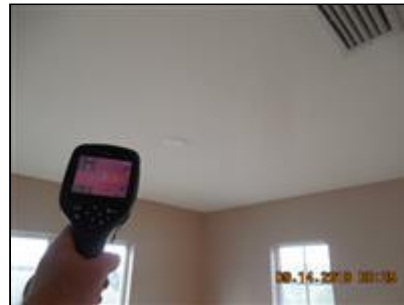
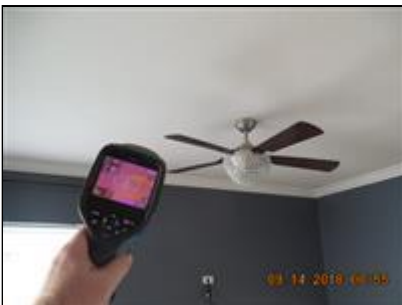
(Pictures 4 - 8) We tested the interior ceiling areas with a thermal camera and/or moisture meter. We did not detect any heightened levels of moisture in the other areas.

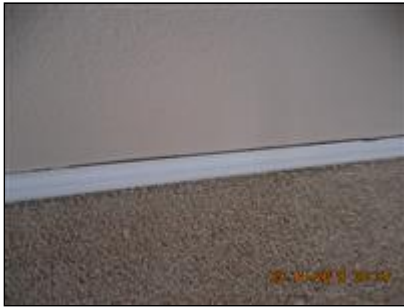
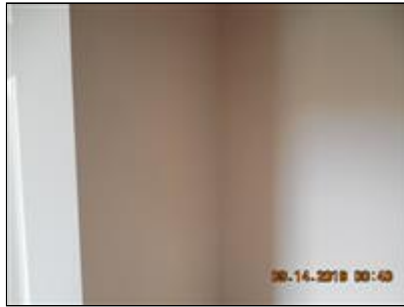
9.3 (Pictures 1 - 6) Overall, the interior of the dwelling is in solid condition.

(Pictures 1 - 13) We tested the interior walls with a thermal camera and/or moisture meter. We did not detect any heightened levels of moisture.

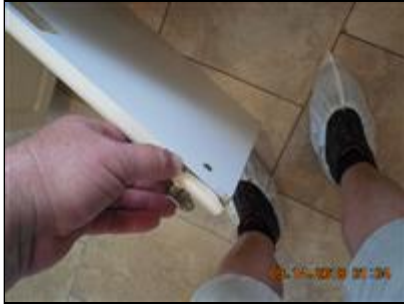
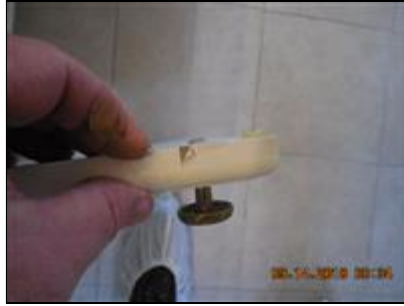
9.6 (Picture 1) (Picture 2) Some of the cabinet doors are de-laminating.

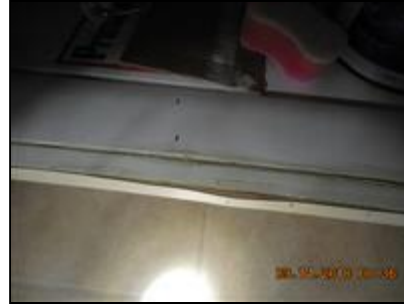
9.6 (Picture 3)

(Picture 3) The guest bathroom sink cabinet shows signs of water damage and attempted repairs.

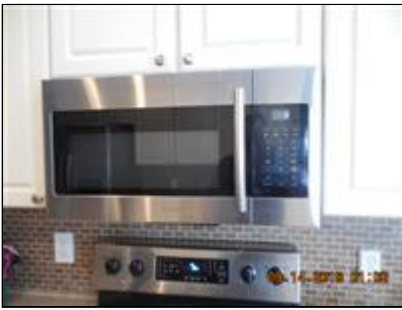
10.4 (Picture 1)

10.4 The microwave was tested and operated as intended.

However, it is noisy.

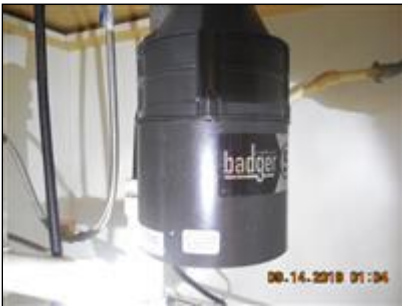
10.5 (Picture 1)

10.5 The food waste disposer was operated and functions as intended.

However, it is noisy.

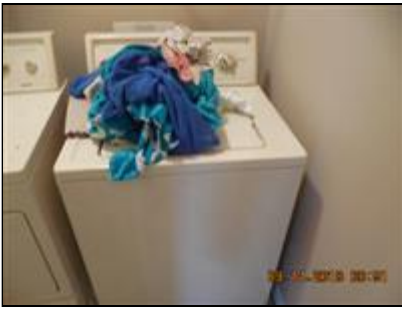
10.7 (Picture 1)

10.7 The washer was tested and found to be working.

However, it was humming at the end of its cycle.

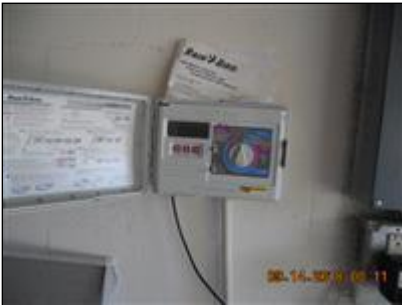
11.1 (Picture 1)

11.1 The control box is located in the garage.

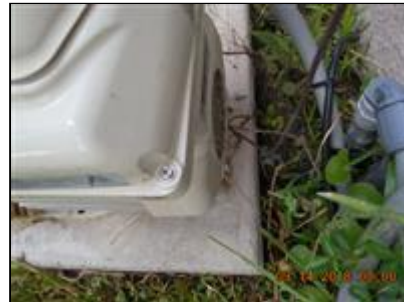
12.6 (Picture 6)

(Picture 6) The pool pump is bonded properly.

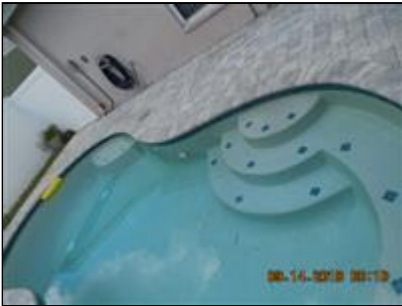
12.9 (Picture 1)

12.9 The skimmer basket should be kept cleared of debris.
